Freeway Medical and GAMA Healthcare Ltd Compatibility statement – Clinell Universal

Freeway Medical Compatibility report

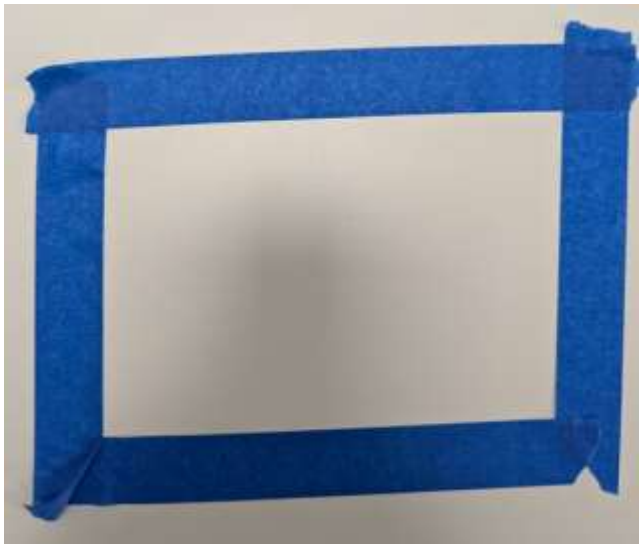
Figure 2 - Sample 2 after 2 weeks exposure to CW200B

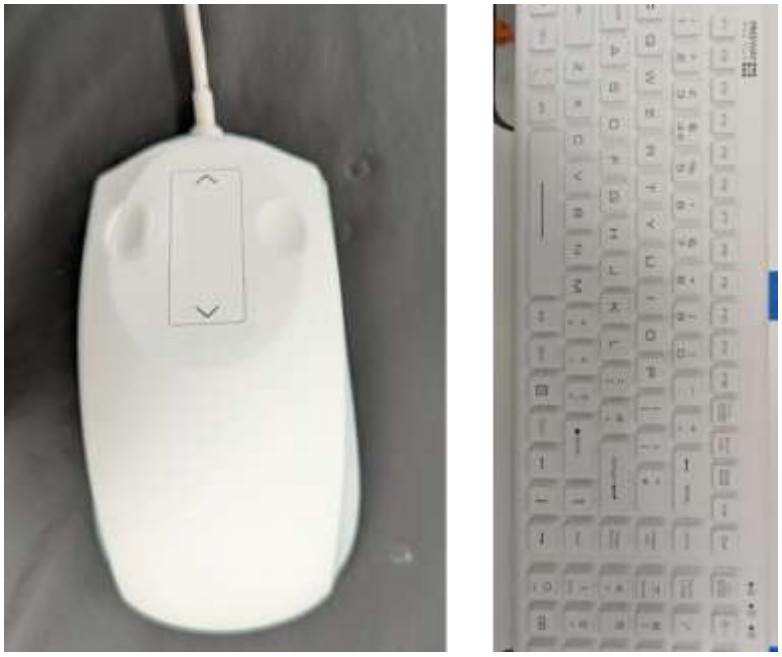
Figure 4 - Sample 4 after 2 weeks exposure to CW200B
